Test of ROV-based harvesting methods for sea urchins and scallops

Part Two: Report on Scallop (stort kamskjell) collection trials

Report no:
30/2012

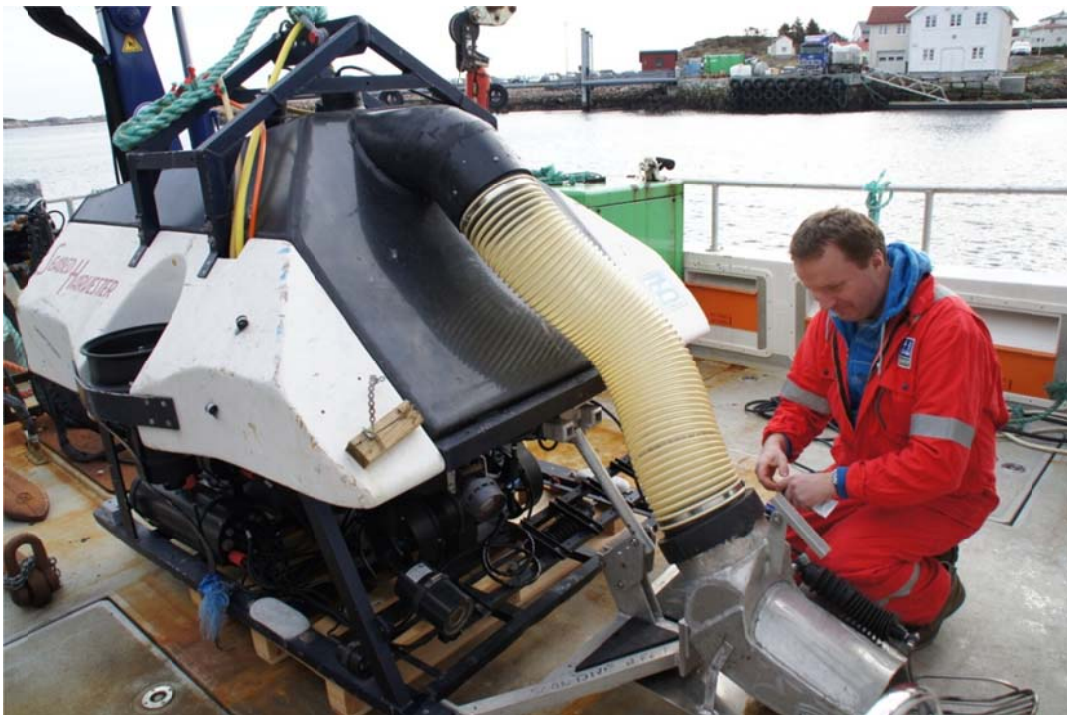
The SeabedHarvester ROV (Figure 3) used throughout this study is a specifically designed ROV for collecting benthic species such as sea urchins and scallops. It is a modified Sub-fighter 7500 ROV (165cm long x 96cm wide x 110cm high, 460kg, running off single phase 230 VAC power source) with a control unit (including monitor: 96cm long x 53cm wide x 63cm high), a remote control unit and a transformer unit. The ROV has been modified with the addition of a suction nozzle that protrudes from the front and is the point of collection. This nozzle is then connected to a storage tray which slots into the main body of the ROV (capacity approximately 100kg). A thruster creates the suction required to suck scallops from

Figure 3 Are Hofstad (CEO of 7S-Technology AS) preparing the SeabedHarvesterROV prior to the trials at Frøya.

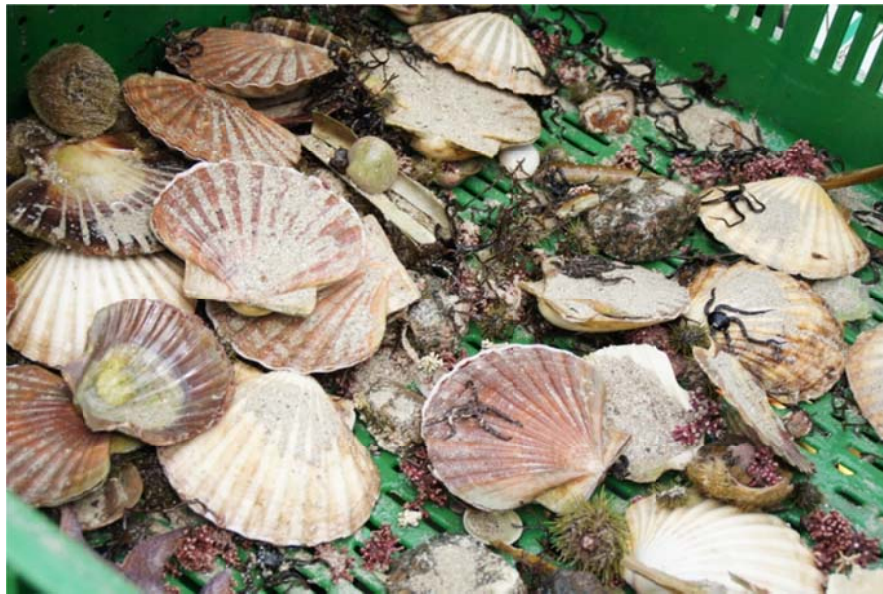
Figure 9 Scallops in the storage tray on 26th April.

During the testing on 26th April a number of scallops collected by ROV were photographed as they were removed from the catch tray (Figure 9) and later in the day a number of scallops that had been collected by divers and were being held in the live storage facilities at Seashell AS were photographed to compare the shell damage in each (Figure 9, 10 and 11).

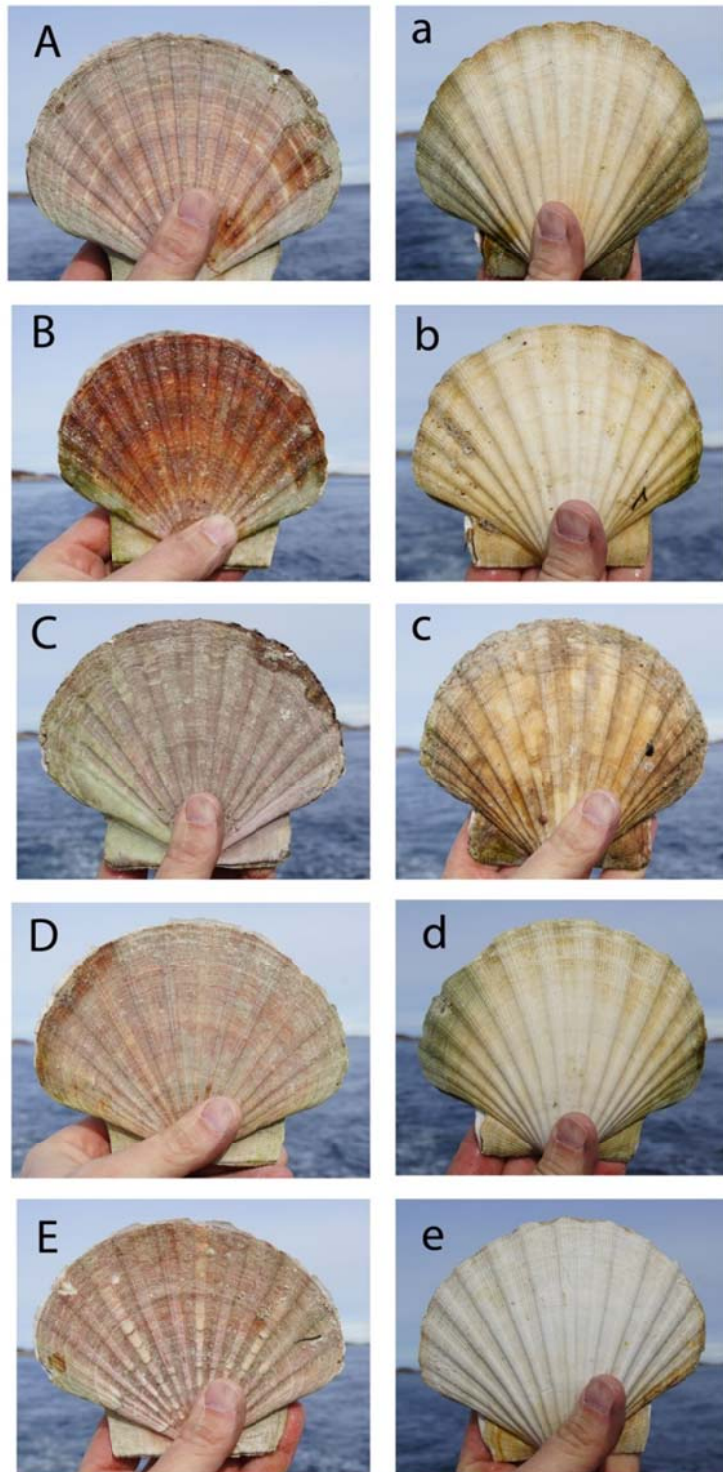
Figure 10 The shell condition of five scallops collected using the ROV (Upper case letters show the bottom side and lower case the top side of the shell).

One of the marketing strategies of Norwegian companies in Frøya (eg Seashell AS) is to promote their scallops as being handpicked and in excellent condition. A visual comparison was made between scallops collected by the ROV and scallops collected by divers for Seashell AS (Figures 10, 11 and 12). The results show there was slightly more chipping on the growing edge of the scallop in the ROV collected scallops but the authors believe it would be very difficult to identify scallops collected using the two different techniques.

There were no obvious differences in shell quality in scallops collected by ROV compared to scallops that were handpicked by divers.

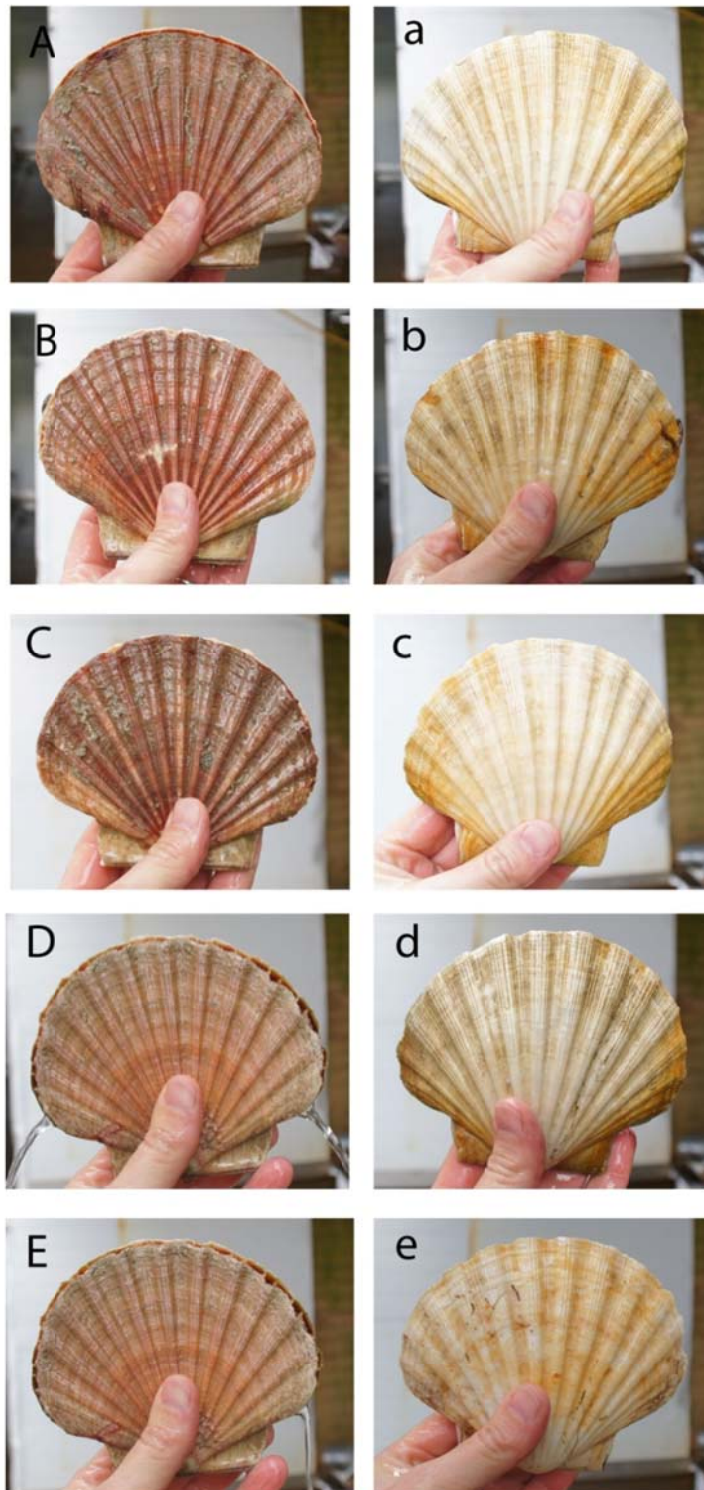
Figure 11 The shell condition of five scallops hand collected by divers (Upper case letters show the bottom side and lower case the top side of the shell).
