## Research Cruise Report [2021825]: FV “Vikingbank” Catch Control in the Blue Whiting Pelagic Trawl Fishery.

*Mike Breen, Jostein Saltskår, Sigurd Hannaas, Liz Kvalvik, Olafur Ingolfsson  
(Institute of Marine Research).*

*Dagfinn Lilleng (Norwegian Fisheries Directorate).*

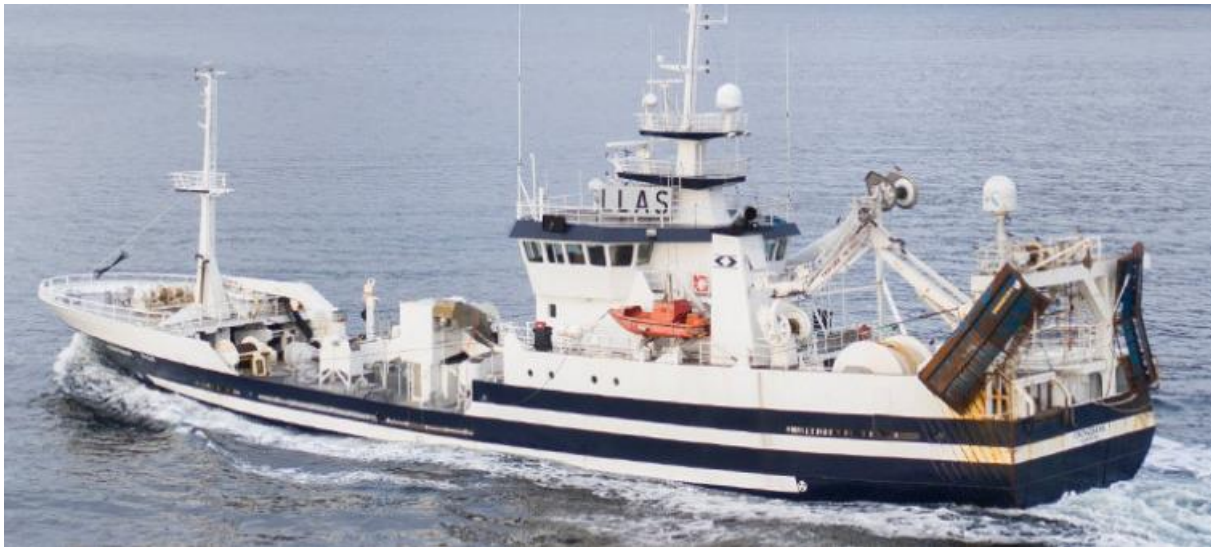
Figure 2 – FV Viking Bank (R-3-K)

MF Vikingbank (R-3-K) [owned by Cetus AS] is 61.75 metres long and has a beam of 11.6 metres, with a gross tonnage of 1190 tonnes. She is a combination vessel, capable of fishing with either pelagic trawl or purse-seine. For fish location and characterisation the vessel is equipped with Simrad SU 90, Simrad ES 70 and Furuno TimeZero sonars.

For this cruise, the vessel was equipped with a pelagic trawl from Vonin, Capto 2016, (2016 metres stretched circumference), fitted with a  $\sim 1300\text{m}^3$  capacity codend (Appendix B). The total length from trawl doors to codend was approx. 875 meters. Thyborøn 3.5 tonne ( $13.11\text{m}^3$ ) trawl doors were fitted to the upper sweeps, while the lower sweeps were weighted with  $\sim 1.5$  tonne chain bundles. The trawl winch system was controlled using a Pentagon Autotrawl system.

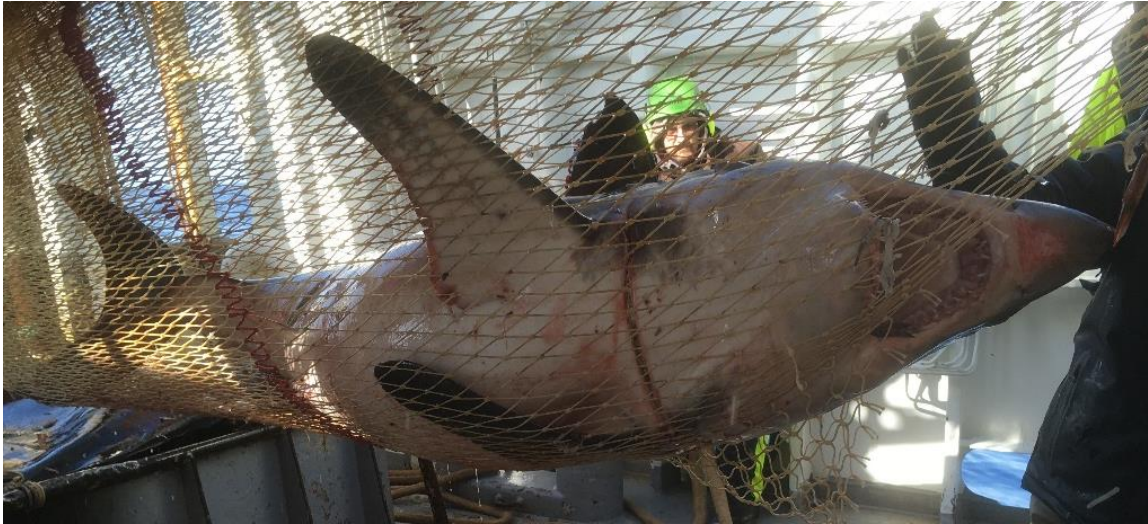
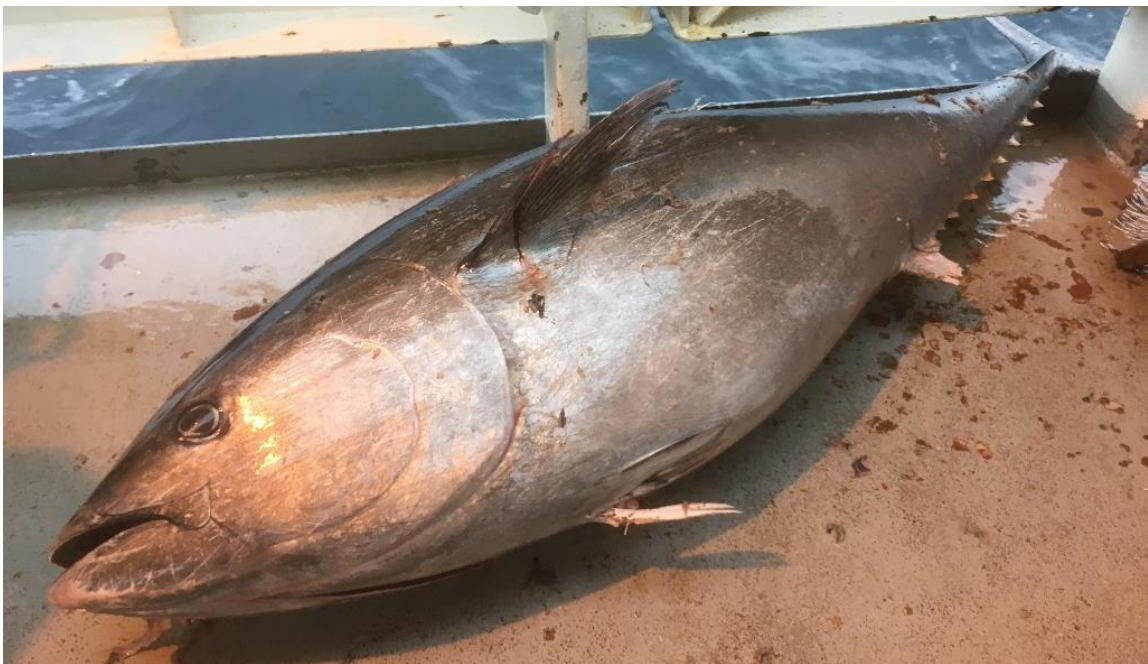
Figure 10 – Top: Porbeagle (*Lamna nasus*) caught in haul 07 and released alive; Bottom: Tuna (*Thunnus thynnus*) caught in haul 09, but was dead on arrival on deck.

In haul 05, a porbeagle and bluefin tuna were observed to be caught in the trawl ahead of the catch control rig (CCR), as it was heaved to the boat. The porbeagle was caught by its teeth in the netting, but was successfully cut free from the netting on deck and released alive back to the sea, after a crew member cut a plastic strip from around its thorax. The tuna remained in the water and was successfully released alive from the trawl by slipping it out of the escape opening in the CCR (Rig 2), suggesting that a CCR with large bottom openings could be further developed to reduce the bycatch of unwanted large species in the catch. There were a further three hauls (08-10) with bycatch (one porbeagle and three tuna), but unfortunately none of these animals were released alive.

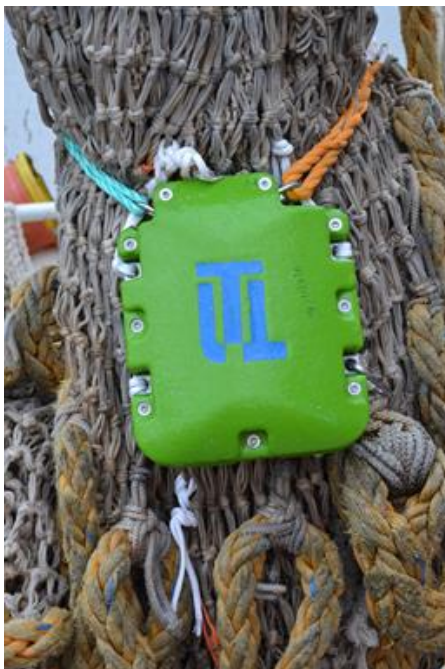
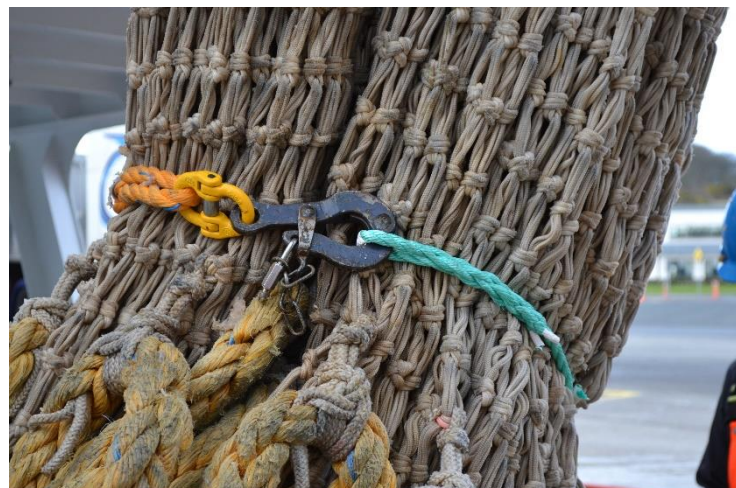
Figure 13: FossTech’s prototype Catch Limitation Release (CLR). Left: CLR unit fitted to codend. Right: restrictor line and fastenings.

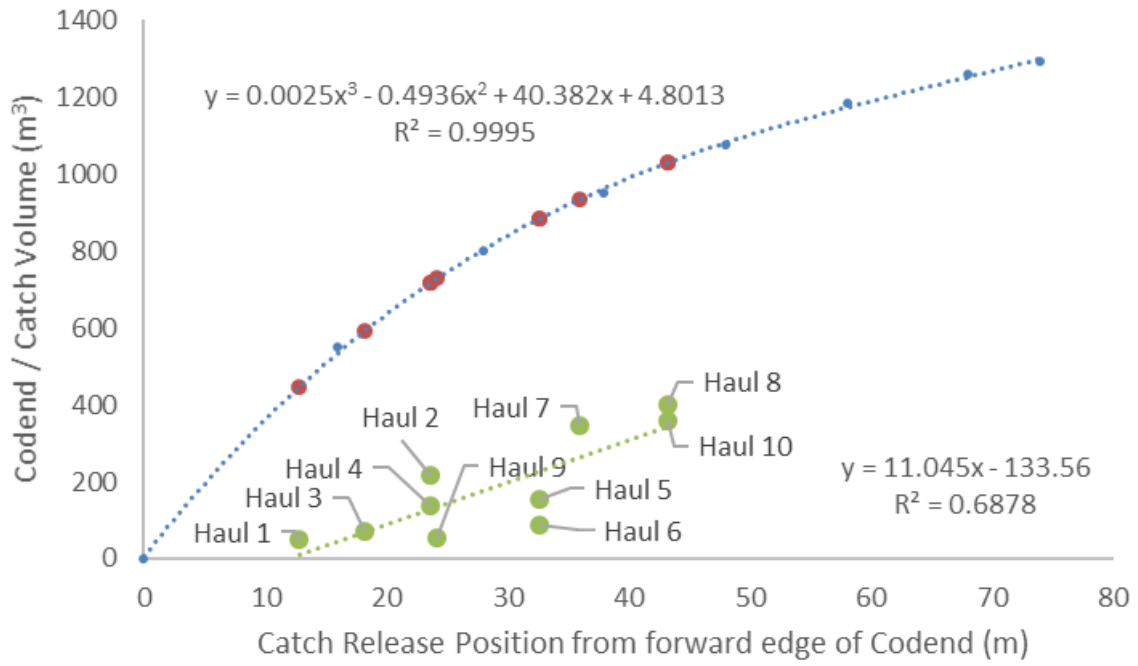
Figure 15 - The relationship between the position of the Catch Limit Release and the resultant codend and catch volumes. Theoretical (third order polynomial) codend volume estimates are shown in blue, and theoretical volume calculated specifically for each haul in red. The resultant catch for each haul is shown in green, with a fitted linear relationship.

Finally, as anticipated, the resultant catch volume (and weight), generally increased the further aft the CLR was positioned on the codend, as the theoretical volume of the receiving codend increased (table 4 and figure 15). However, the resultant catch volumes only represented a small proportion of the corresponding theoretical codend volumes (range 0.07 – 0.39)(table 3). In addition, larger catch volumes generally occupied a higher proportion of the corresponding theoretical codend volume. One possible explanation for this is that larger codend volumes may allow higher densities of catch to accumulate before “excess catch” begins escaping from the openings in the CCR. This could be related to the increased time required to collect larger catches, which may increase the probability of fish becoming exhausted and falling back to the rear of the codend, as time progresses. This process could be verified by appropriate positioning of cameras and/or Trawl-Eye units along the codend.

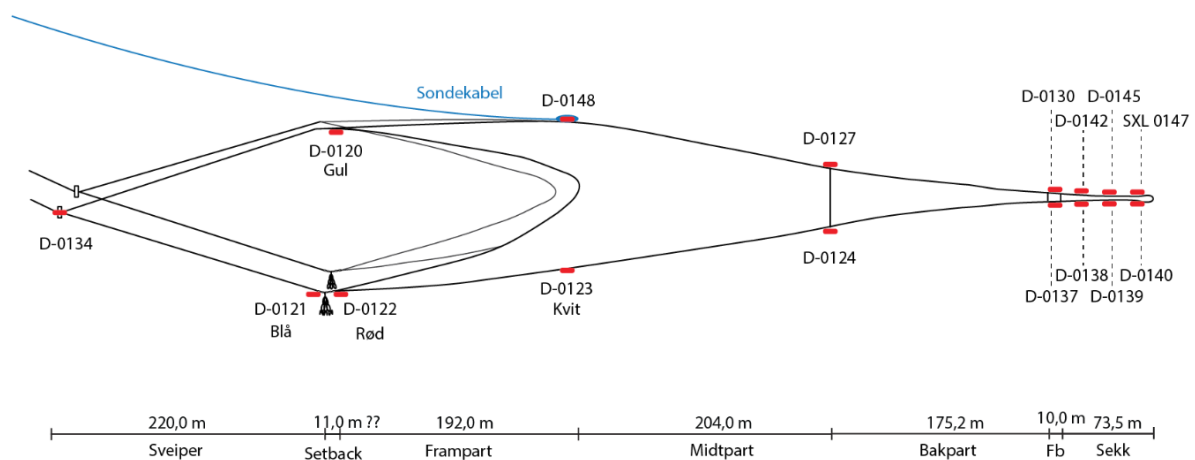
Figure 16 - Positions and Identity Code for depth sensors on the trawl. Detailed positions for the codend depth sensors are detailed in table 5. Note – Sensors D0124 and D0127 are incorrectly located in this diagram, they were actually 60m ahead of the Catch Control Rig. [Source: Liz Kvalvik].

On this research cruise, the trawl was fitted with fifteen Star-Oddi Starmon TD (depth & temperature) and one Star-Oddi Starmon Tilt (depth, temperature & 3D-tilt) sensors (see figure 16 and table 5 for position details). Each sensor was protected inside a steel cylindrical housing, inside a webbing sheath (figure 16), with the exception of D.0148 which was housed inside the FS 70 Trawl Sonar housing. Depth sensors D-0120 to D-0123 were fitted and removed at the start and end of each haul, to prevent them being damaged on the net-winch drum. Each was colour coded (to match the trawl colour-code system) to aid accurate and consistent placement each haul. Details of trawl and trawl doors are provided in section 2.1.

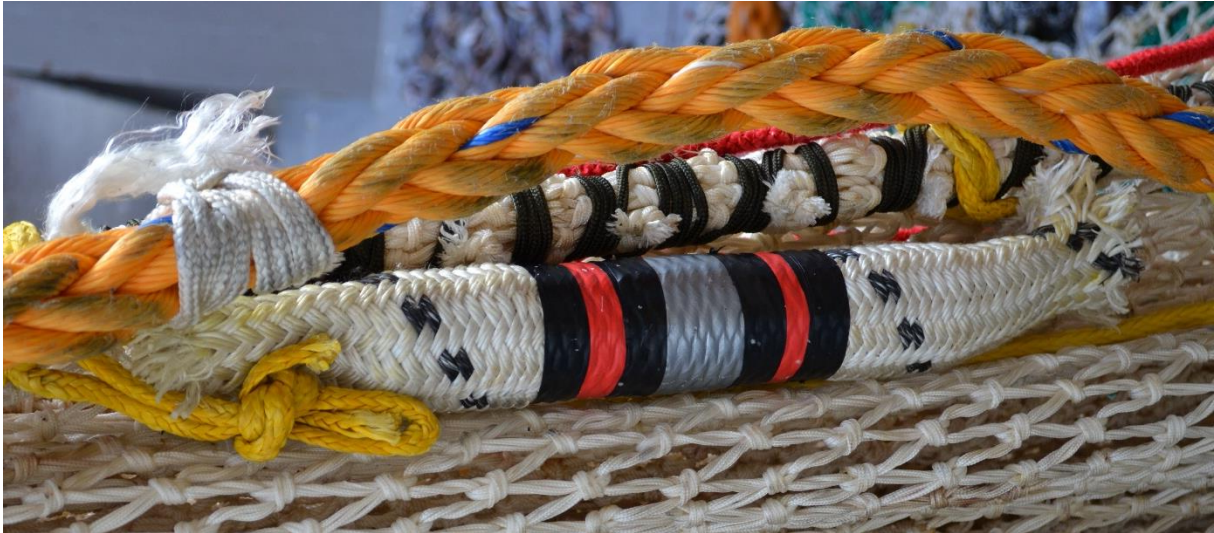
Figure 17 – a depth sensor (D-0130) in its protective housing and sheath fixed to the top of the CCR.

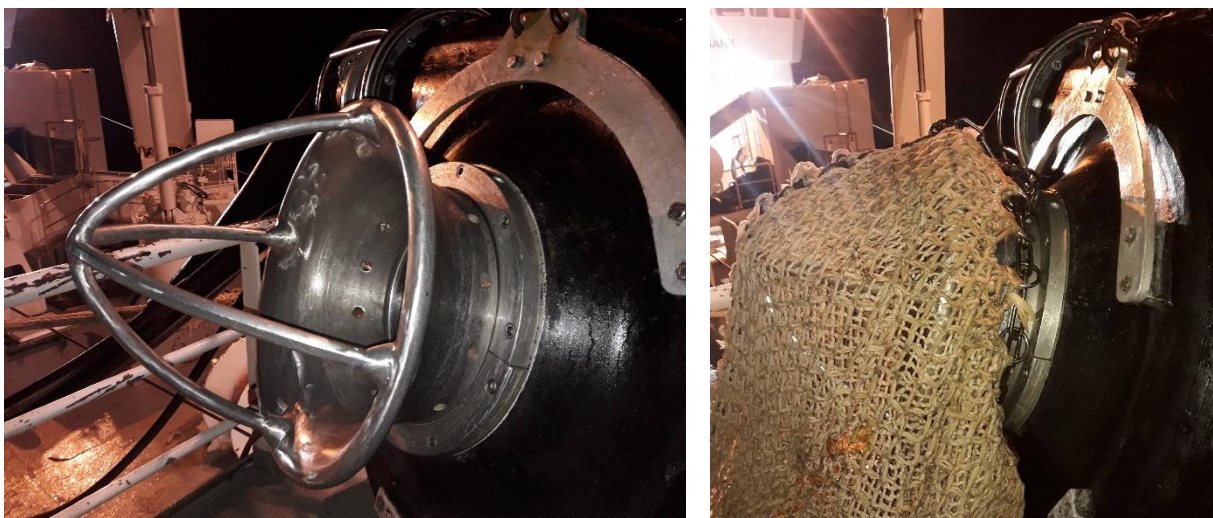
Figure 18 - Left: the pump-head funnel; and Right: pump with pump skirt connected [Source: J. Saltskår].

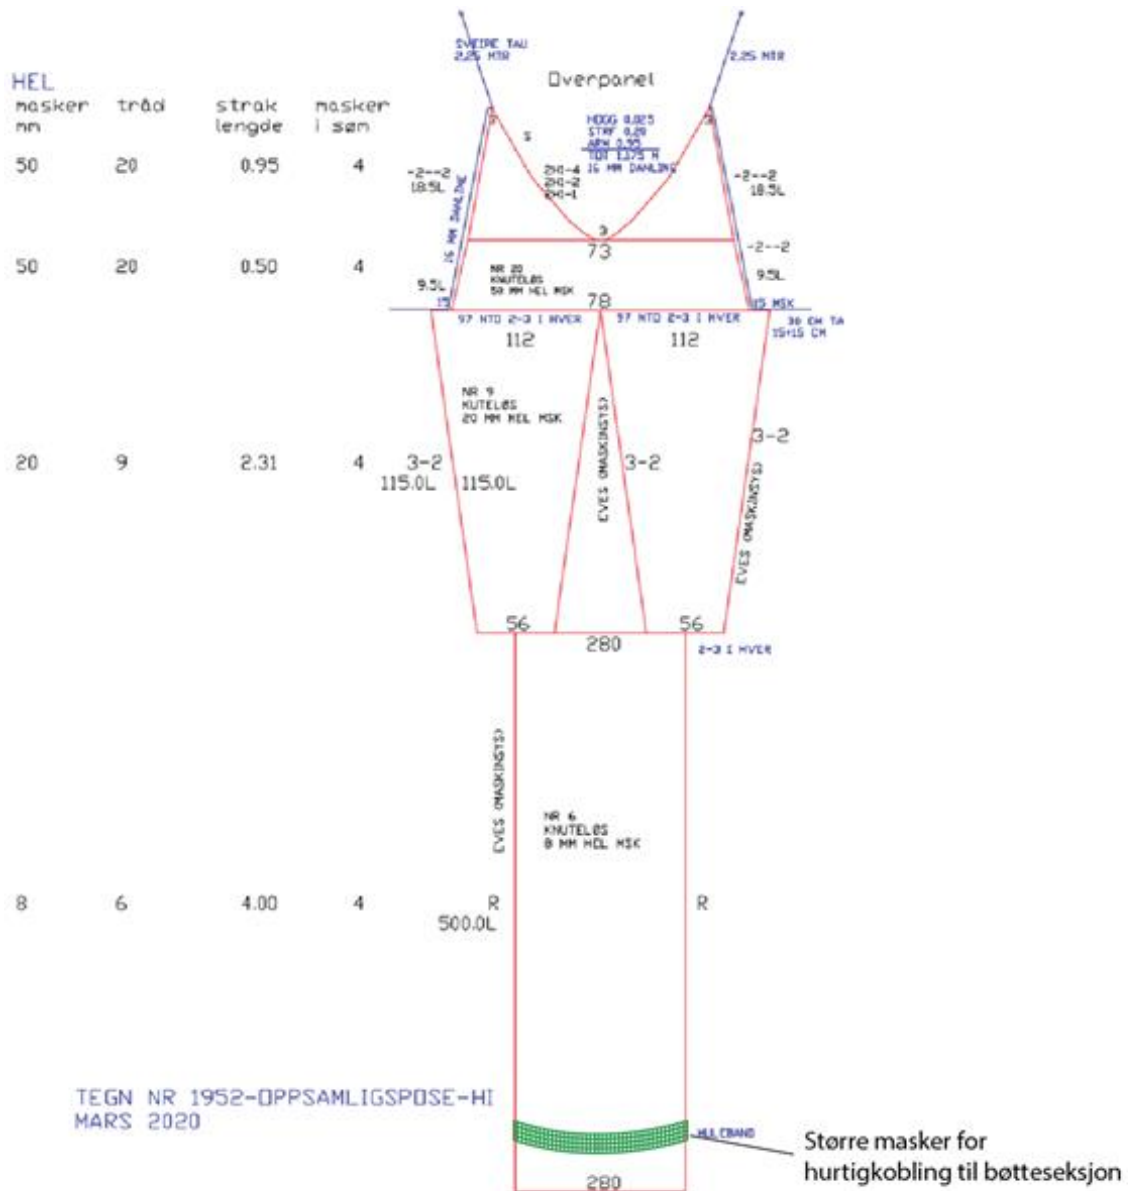
Figure 22 - Plan of the release opening sampling trawl [Source: O. Ingolfsson/L. Kvalvik].

A small sampling trawl (figures 21 and 22) was tested to establish whether it could collect a small sample of fish (~30) escaping from the opening in the CCR and deliver that sample to the vessel with minimal physical trauma and injuries induced by the sampling process. As the preferred release opening is in the bottom panel of the CCR (see section 3), it was necessary to adapt the sampling trawl to work upside-down, because it was initially developed to float above a release opening. To facilitate this change, small weights were added to the sampling trawl “headline” when it was deployed in haul 04. This was later modified to a length of chain along the full length of the headline, in haul 09.

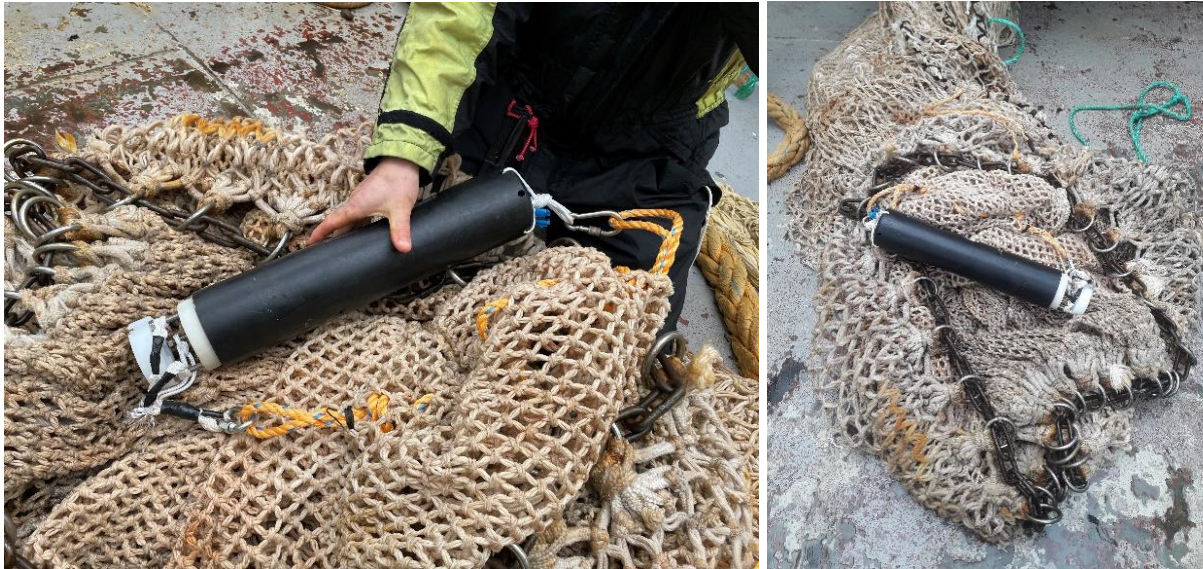
Figure 23 – Rinko oxygen logger, inside protective housing, being fitted inside the codend skirt before was coupled with the fish pump during Haul 03.

To monitor oxygen concentrations in the pumped catch, a Rinko 1D oxygen logger (inside a protective housing) was fitted inside the codend skirt during pumping in haul 03. This provided oxygen concentrations (% saturation and mg/l), as well as temperature (°C) and depth (m), every second.

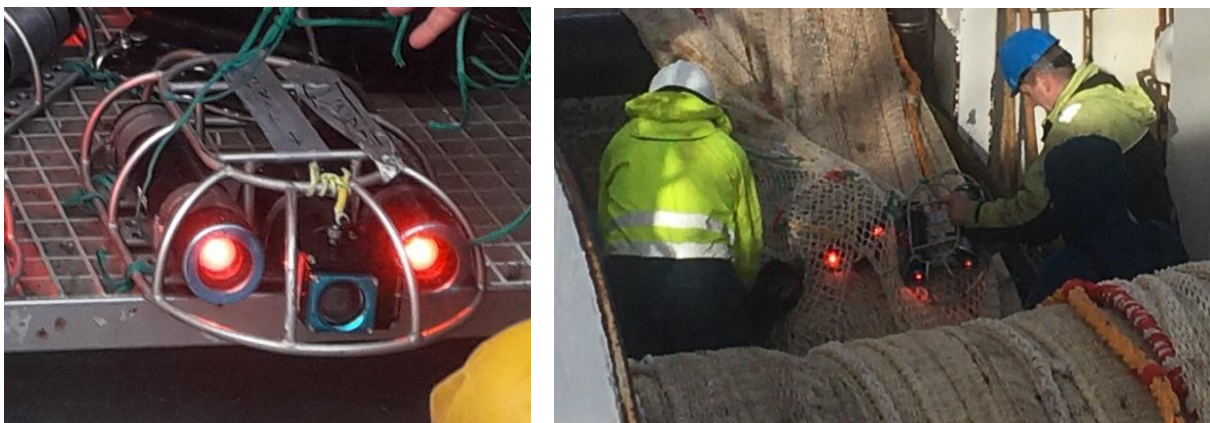
Figure A1 – “dome-frame” with camera (in a B-group housing), and with two red lights (left), and being fitted/removed from the trawl (right).

The main camera system used underwater observation was the “dome-frame” containing a camera (GoPro 5 or 7) in a GroupB Benthic+GPH deep-water housing, with two Brinyte DIV01 diving lights (Red or White; see below for more discussion) in GroupB GPH deep-water housings (figure A1). This is a very robust and versatile camera/light rig, that is ideally suited for the challenging conditions encountered in this fishery. Although, because of the necessarily low-profile of the frame, the camera has a limited perspective (only approximately half-view) when attached to a closed/small mesh netting panel (see below for further discussion). As discussed, the most reliable camera was the GoPro 5; which we now have only a few of. Therefore, it is strongly recommended that we source more GoPro 5s or find an alternative camera/housing combination to fit the “dome-frame”. Furthermore, it is also recommended we make at least three more “dome-frames” (we currently have 3), to maximise camera placements and/or optimise turn-around times.

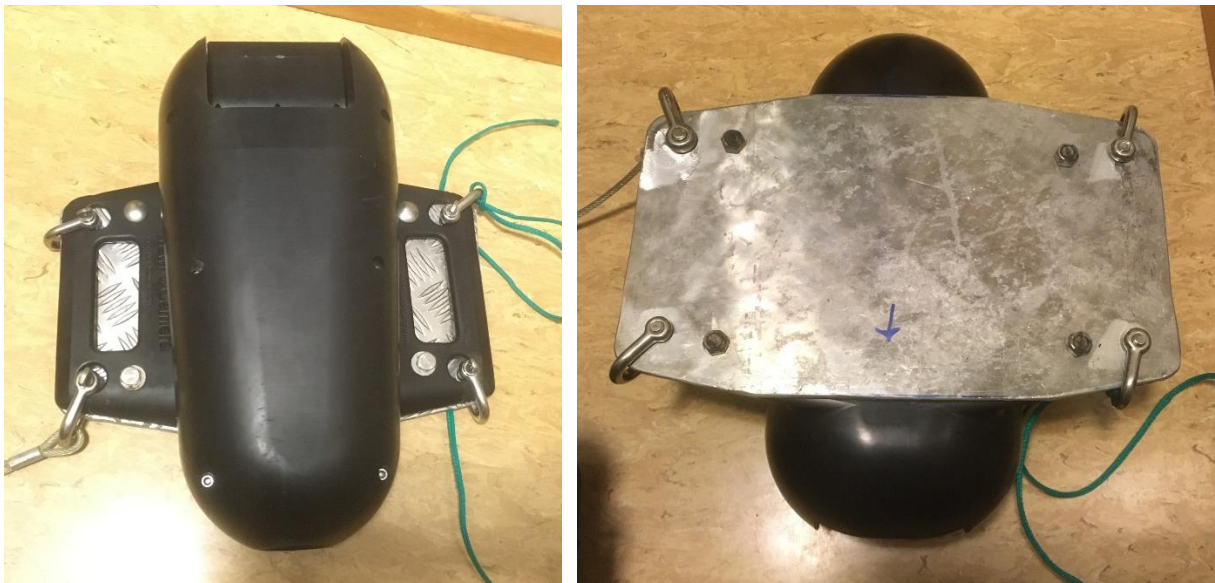
Figure A2 – the JT Electric Trawl Camera (Left), with a reinforcing base-plate fitted by the Vikingbank's engineers during the cruise (right).

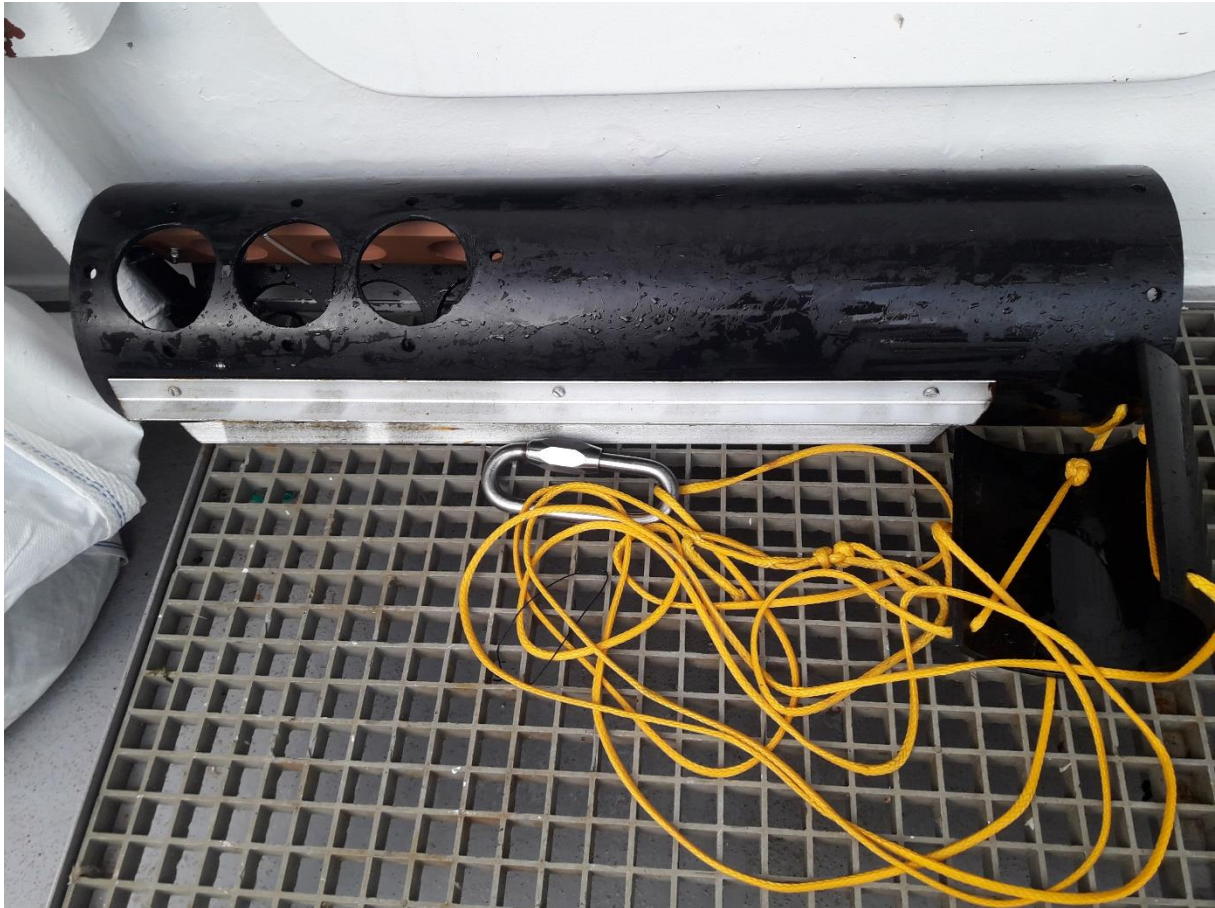
Figure A3 – the “Flying Camera” housing with tether line (Dyneema) and kite [Source: J.Saltskår].

The “flying camera” (figure A3), lifted above the subject area using a kite system [positions 3 and 4], has the potential to provide very informative perspectives, both structurally and behaviourally. However, care must be taken during placement and deployment to avoid potential entanglement, e.g. in large open meshes in the escape panels [position 3] or with the codend round-strops [position 4]. Furthermore, it was generally deployed with only one light fitted, which was generally insufficient for clear illumination. It is recommended that future deployments should have at least two lights fitted, and/or if using red lights the subject area could be locally illuminated with a separate “dome-frame” fitted with 2/3 red lights.
